The main aim of this work is to **analyze the degradation and contamination of polypropylene tube shelters during service life**, in order to adequately choose an alternative for the management of the generated plastic waste

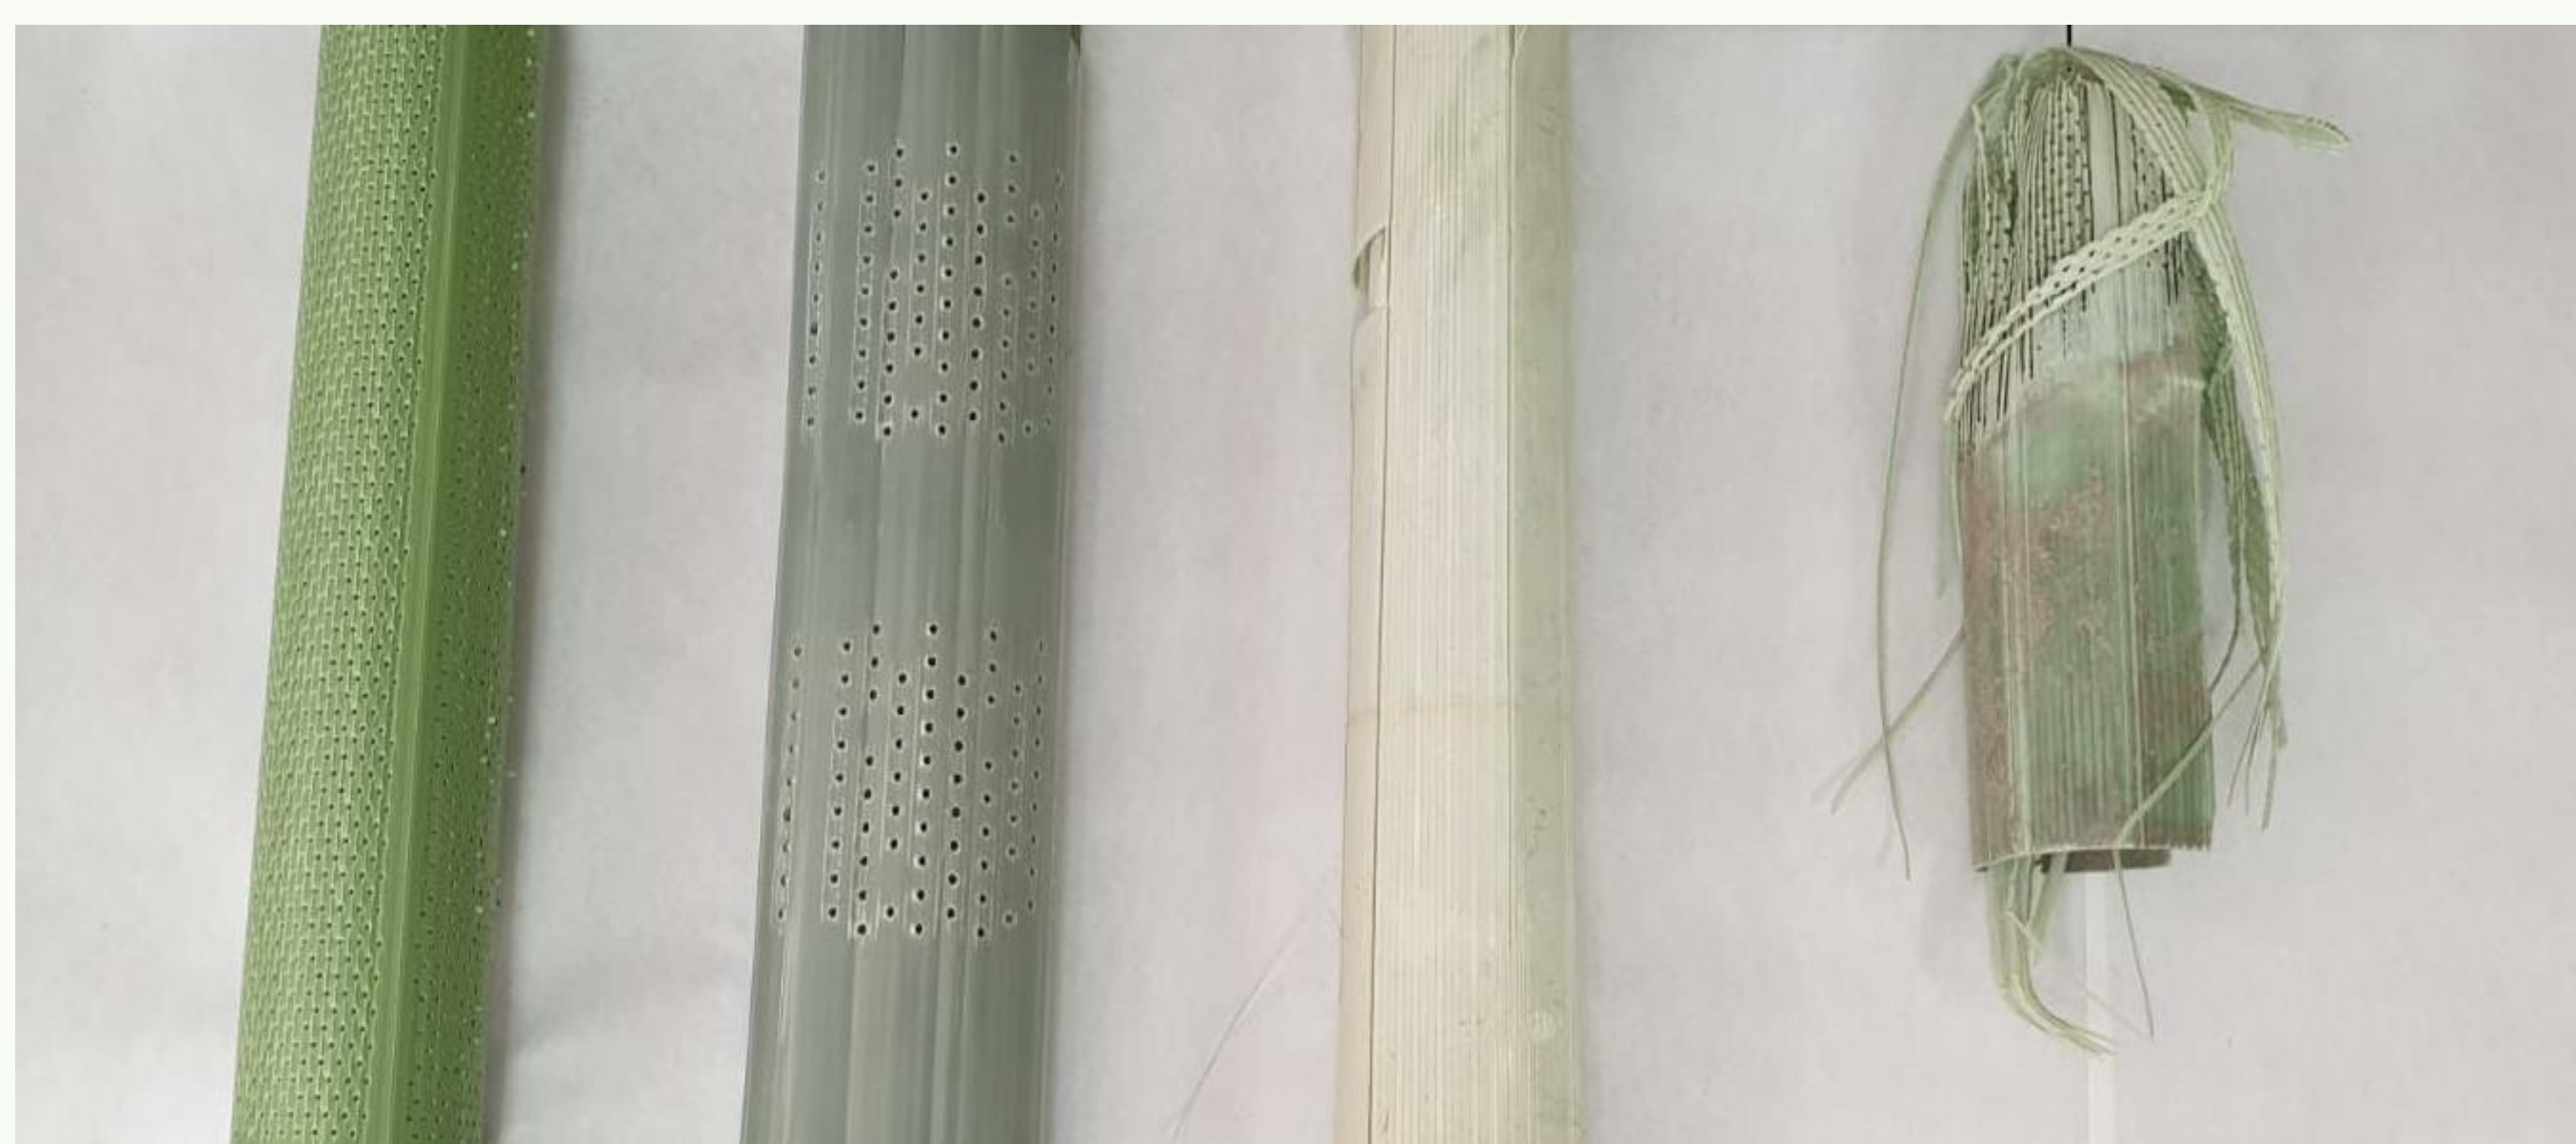
Fig 1. From left to right: new, 5 years, 10 years and 20 years old tube shelters

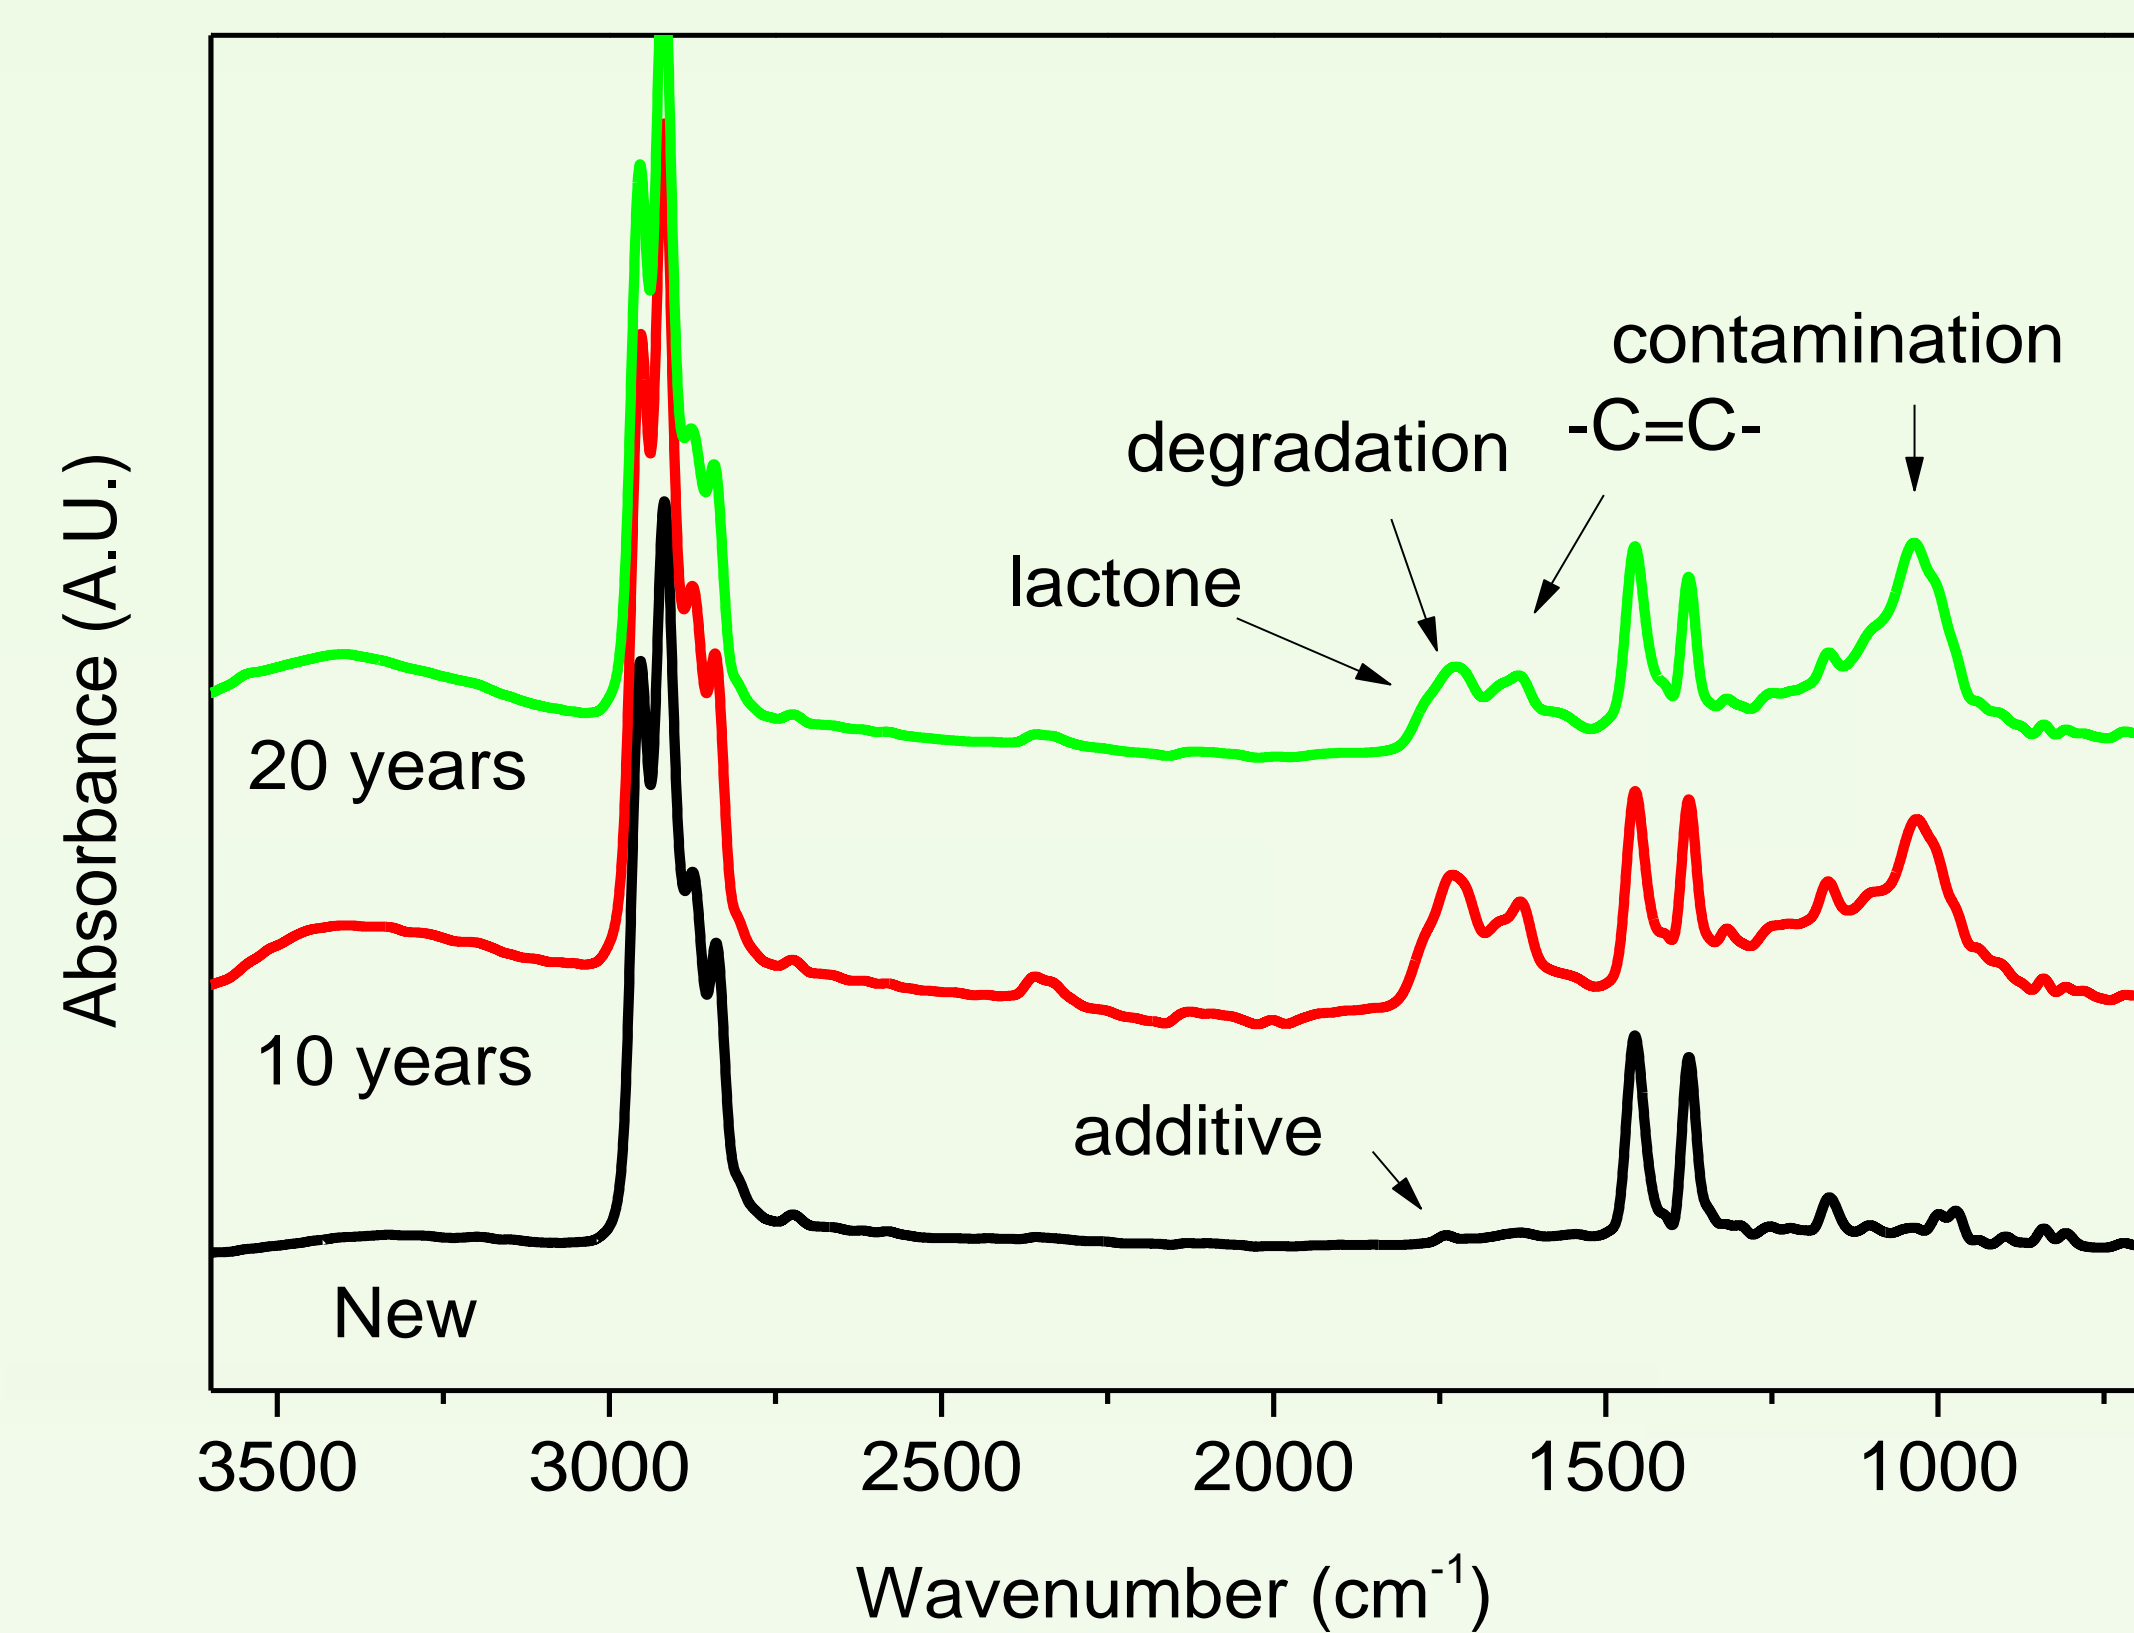
Fig 3. FTIR-ATR spectra of the new, 10 years and 20 years old tubes

- The band centered at **1036 cm⁻¹** can be attributed to the silicates of the soil, indicating the **contamination of the used tubes**.
- The bands between **1600 and 1800 cm⁻¹** correspond to the C=C, C=O and lactone groups. These indicate the **thermooxidative degradation of PP**.
- The band **above 3000 cm⁻¹** is attributed to the formation of hydroperoxides, another product of the **degradation of PP** [3].

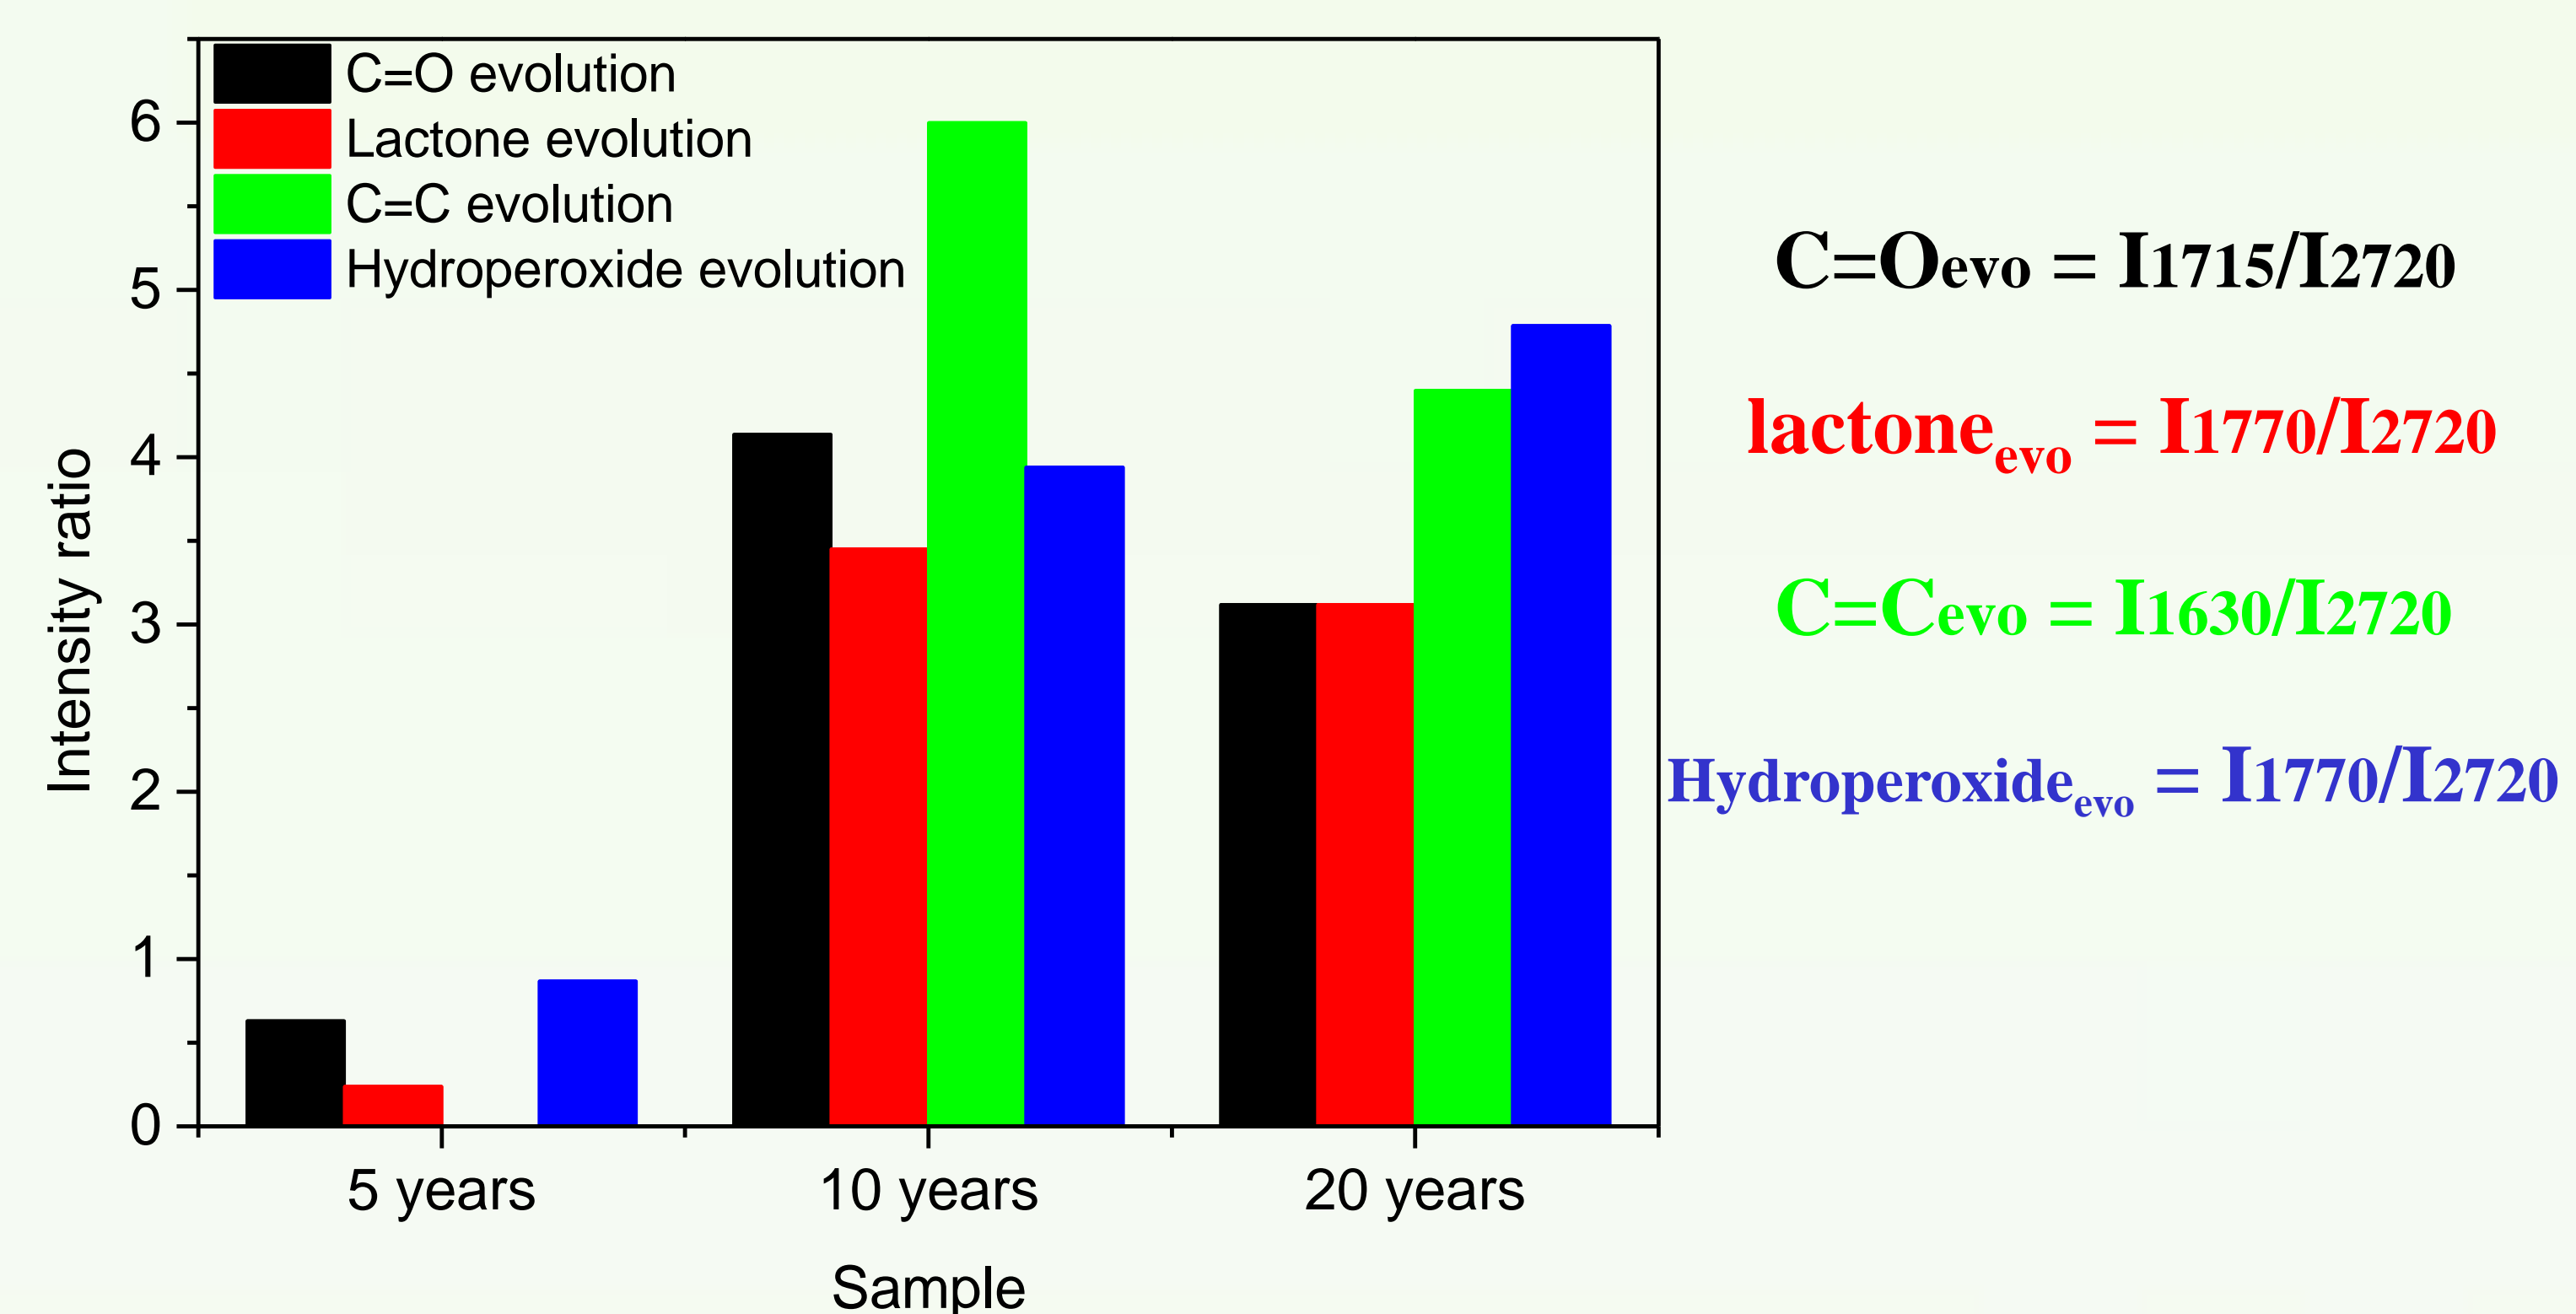
Fig 4. Evolution of FTIR-ATR bands

- All degradation products increase during service life. However, after 20 years hydroperoxides have more relevance
- DSC first heating scans (Fig. 5) show that **after 20 years a second melting peak at lower temperature appears**, due to less perfect crystals. This is a consequence of the presence of shorter polymer chains, **due to degradation processes** [4].

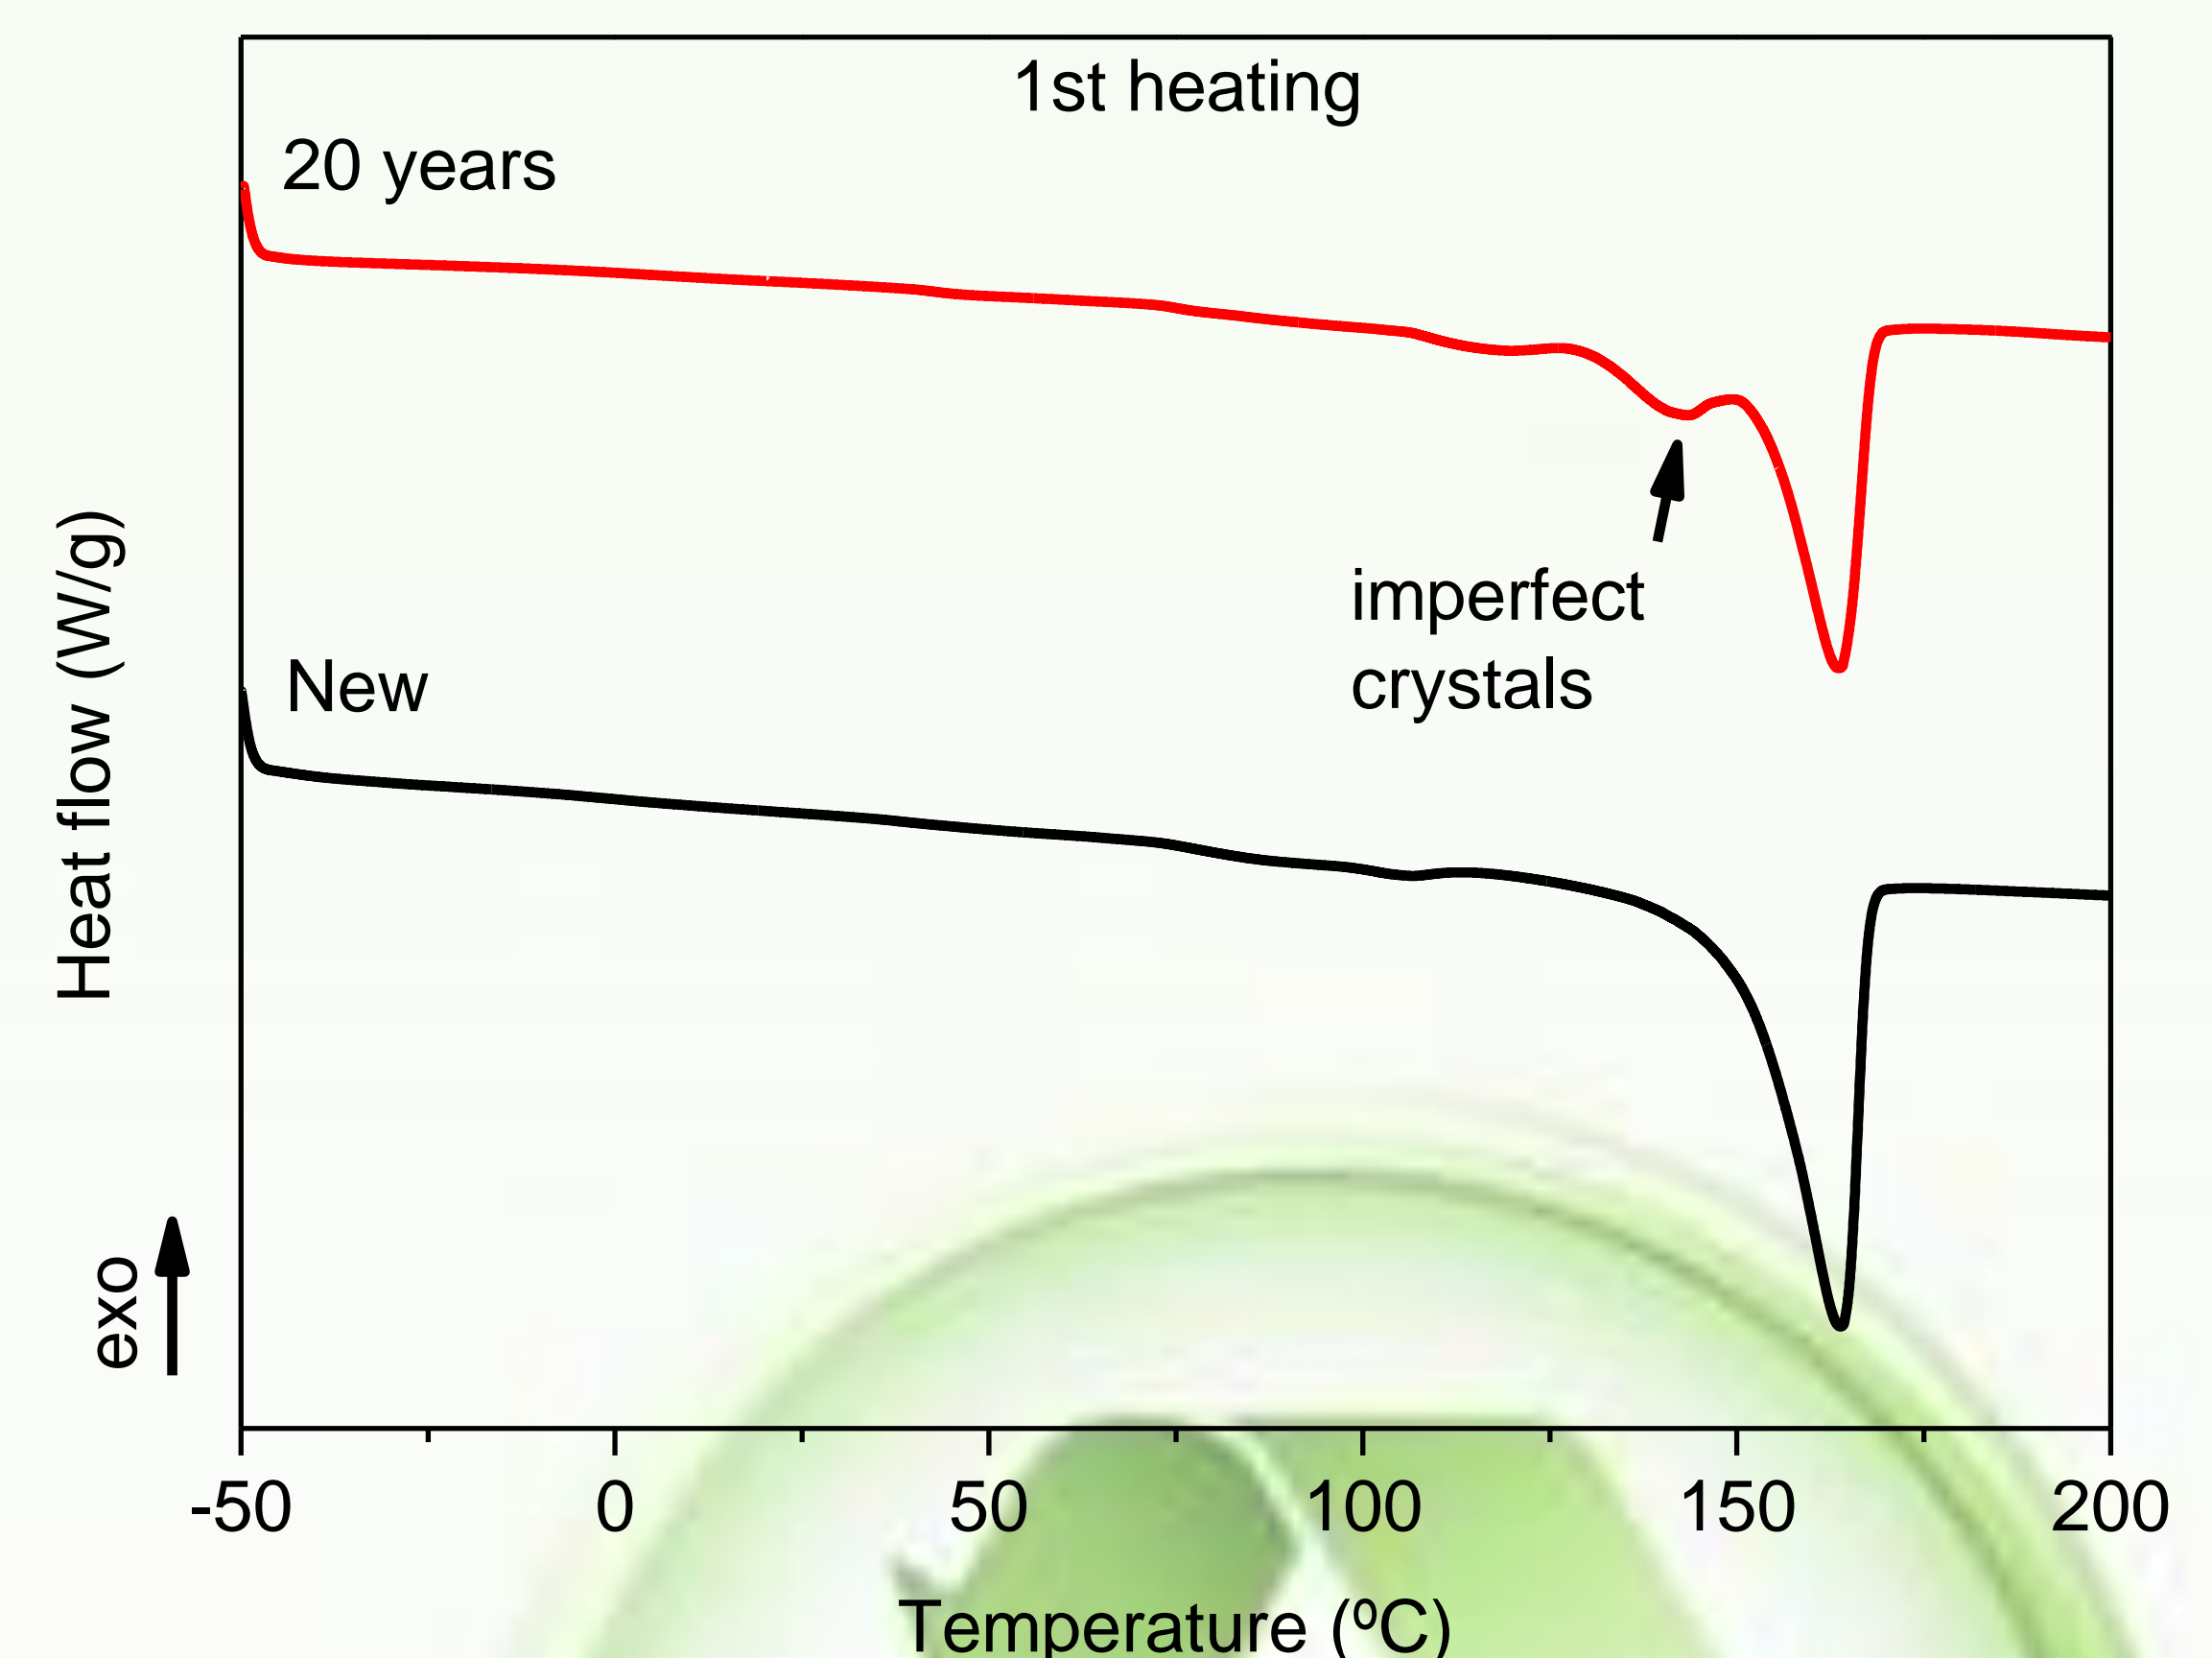
Fig 4. DSC traces after 0 and 20 years of service life
