Modern condition of locations of municipal solid waste in a residential buffer suburb of the city of Almaty

Zaure K. Kaliaskarova

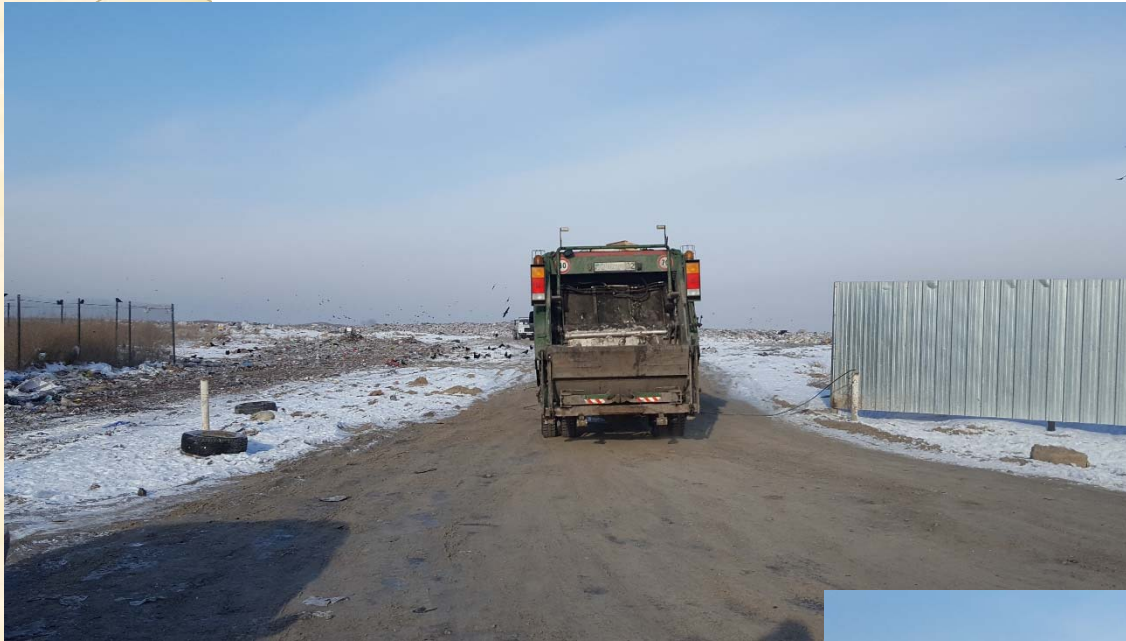
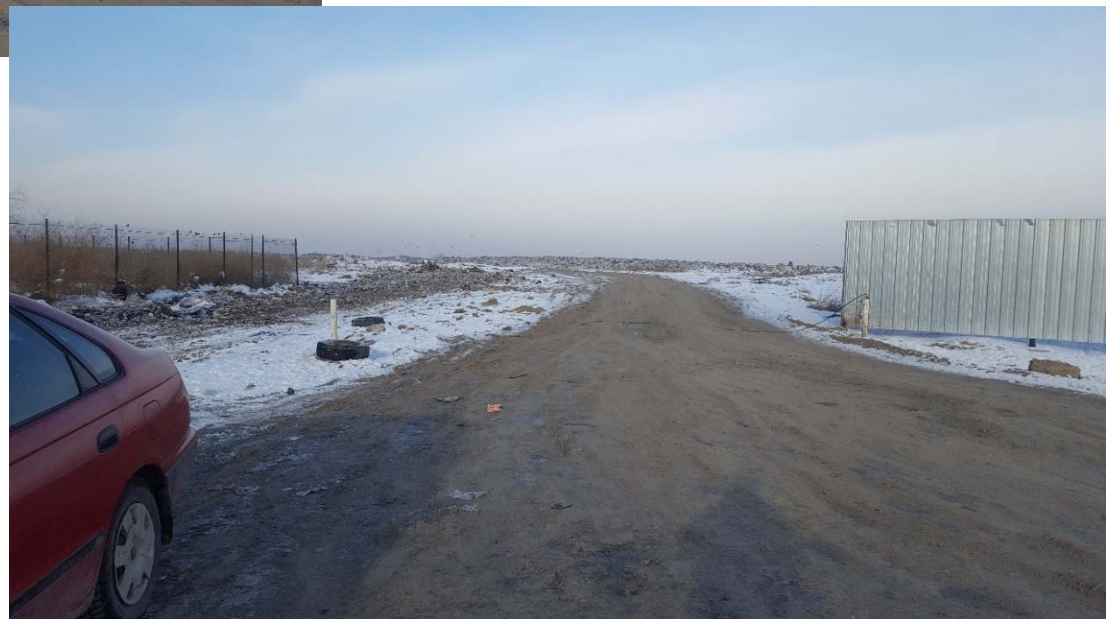
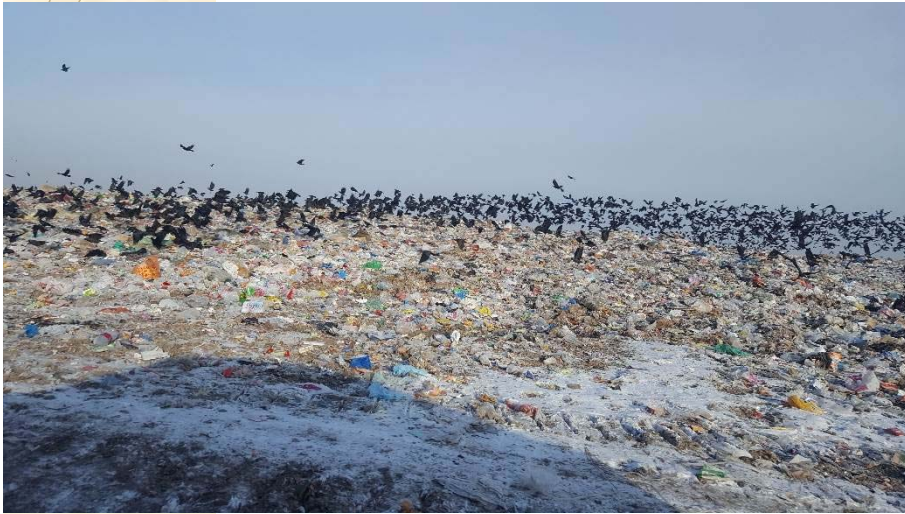
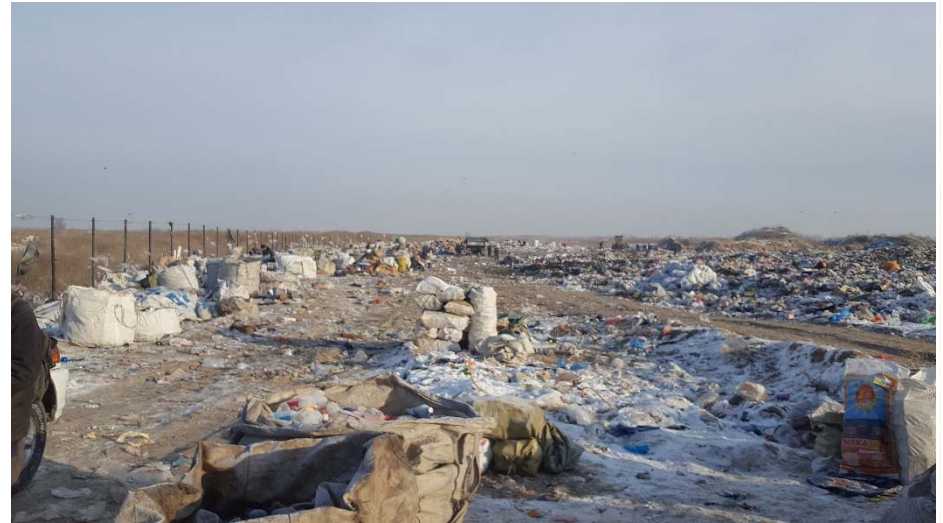
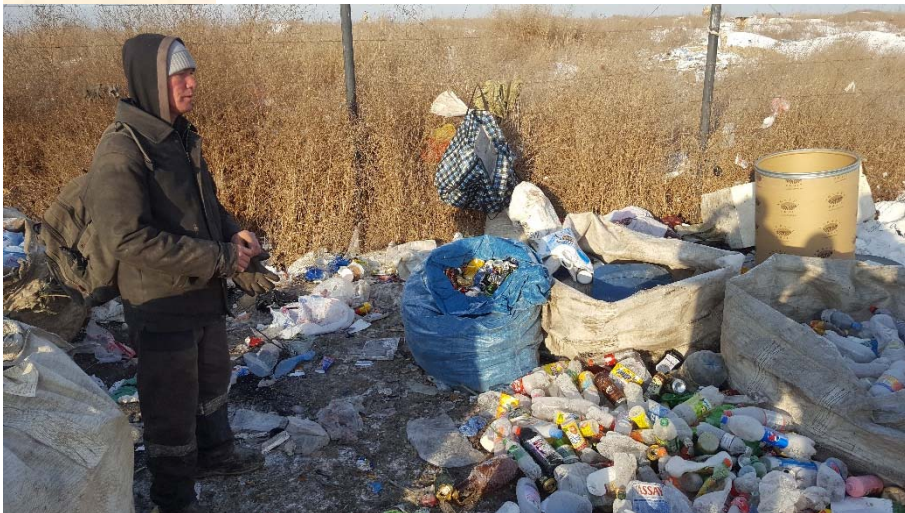
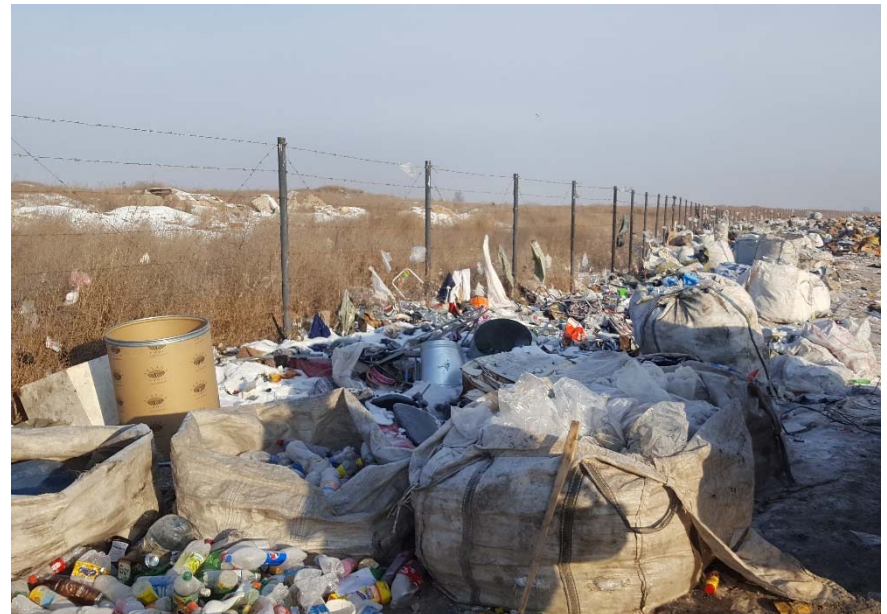
Pictures of the current state with visual observation landfill of Ali "Ile su Kubyry"

Pictures of the current state with visual observation landfill of Ali "Ile su Kubryy"

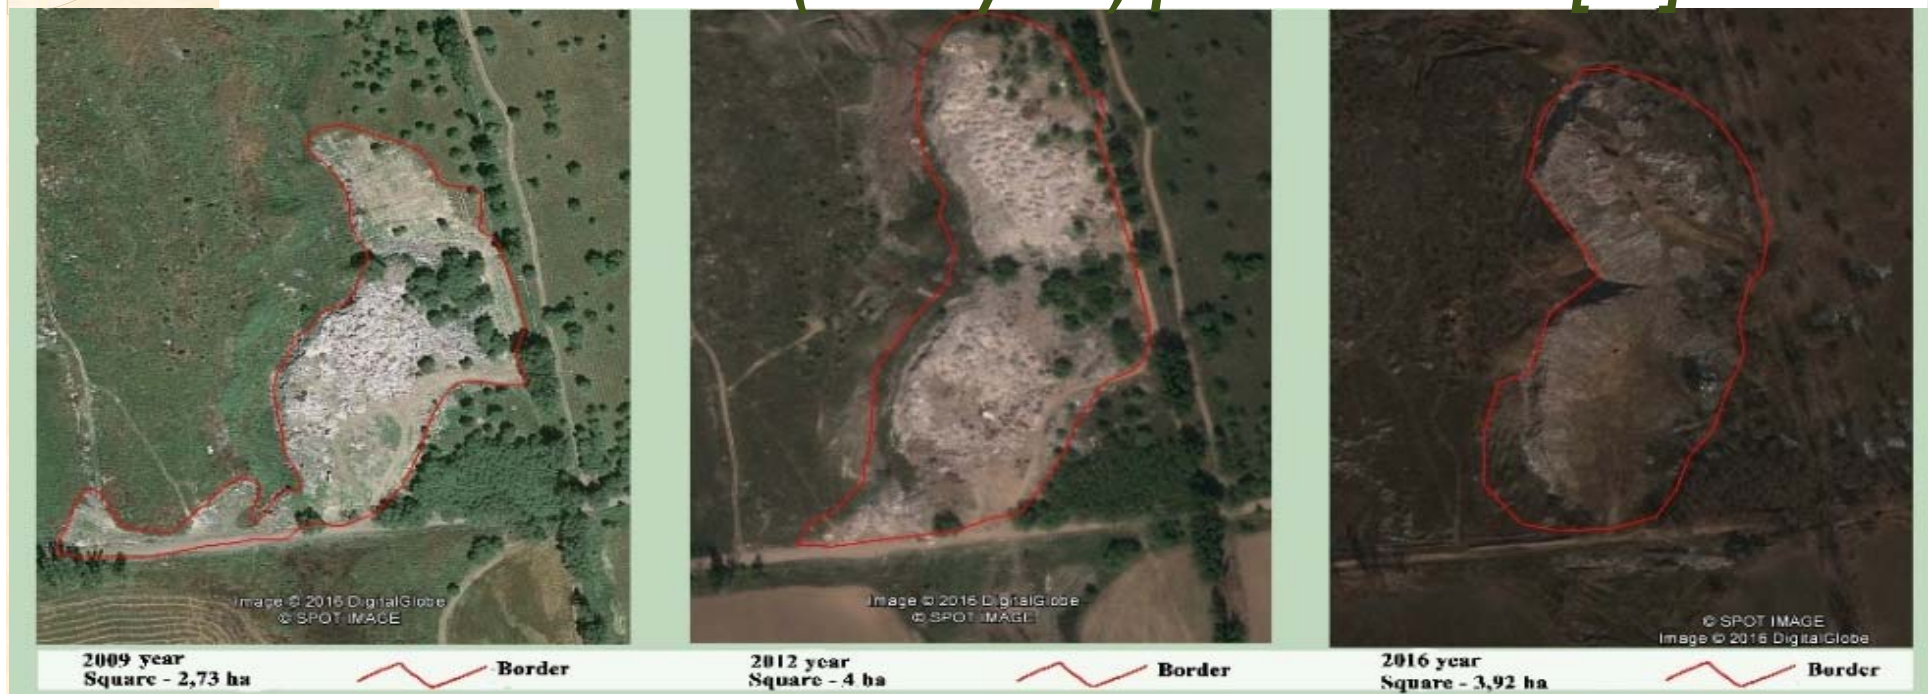
Figure 6 - Dynamics of changes in the boundaries of the dump near the settlement KIZ (Almalybak) for 2009-2016. [28]

- The dump near the village of Kiz (Almalybak) is located in the Karasai district of the Almaty region. The nearest settlements are Almalybak and Zhalpaksay. Lake is located - 19 km at 300 meters to the east of the dump, which contradicts sanitary norms and rules. As it can be seen from the decoded photographs, the area and shape of the dump increased northward from the original shape. In 2009, the dump area was 2.73 hectares, in 2012, it was 4 ha (increased by 1.19 hectares), in 2016, it was 3.92 ha. (Figure 6). The reduction of the boundaries of the landfill in 2016 is related with a partial backfilling of the surface occupied by the waste with the land.

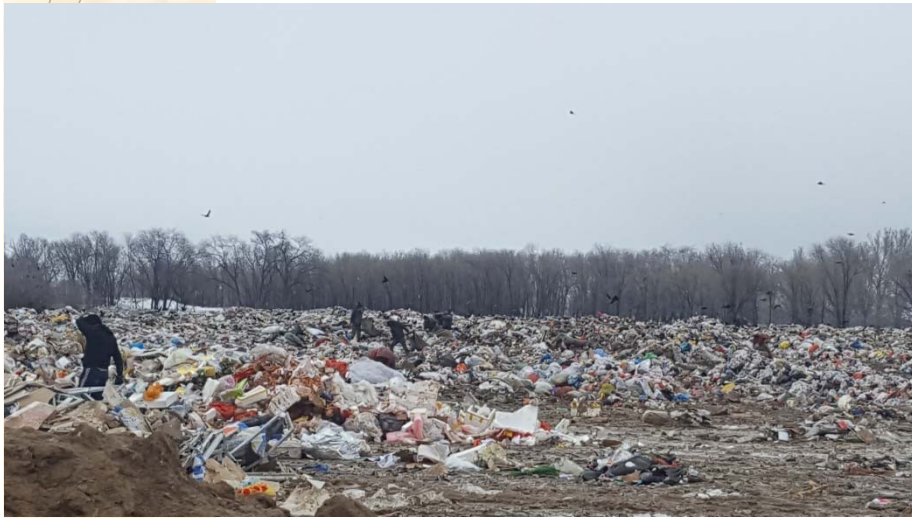
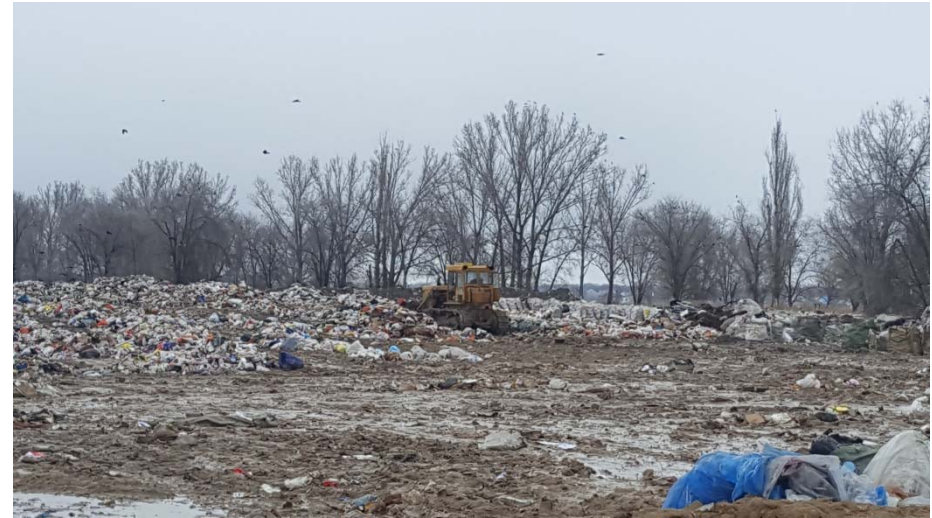
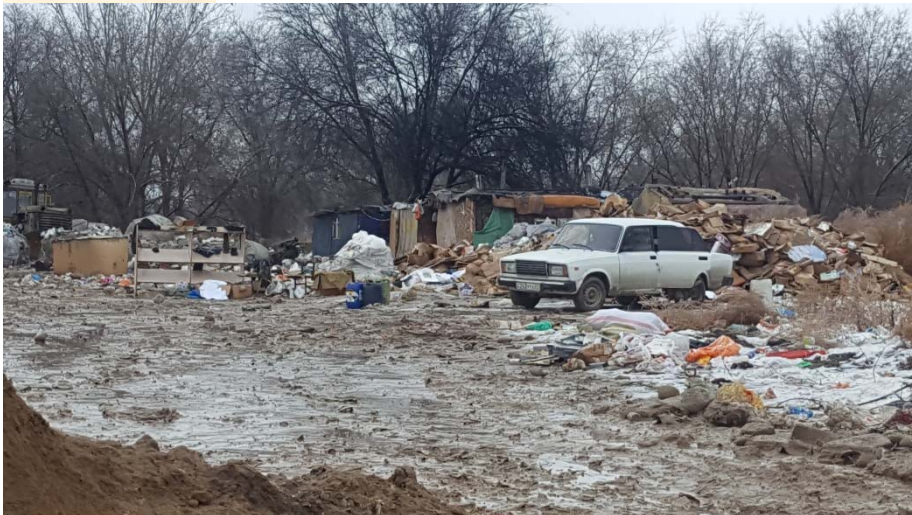
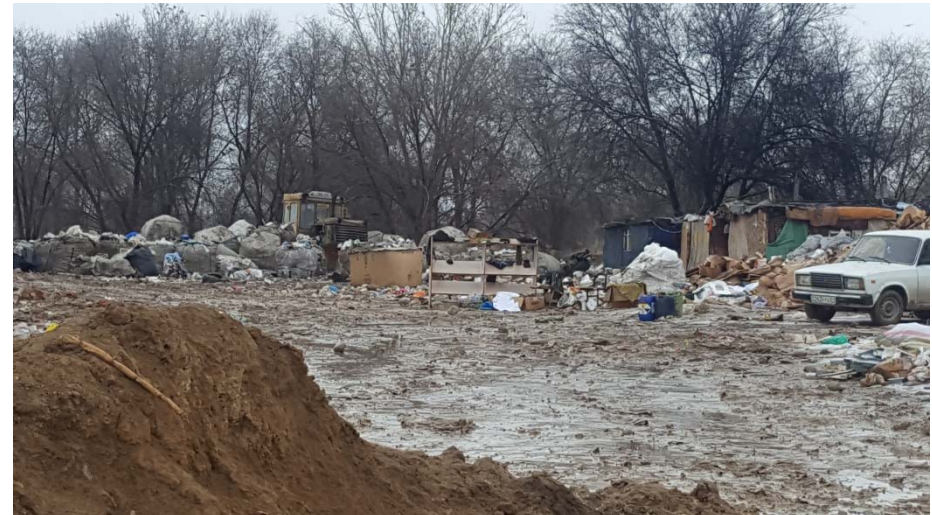
Pictures of the current state with visual observation *the settlement KIZ (Almalybak)*

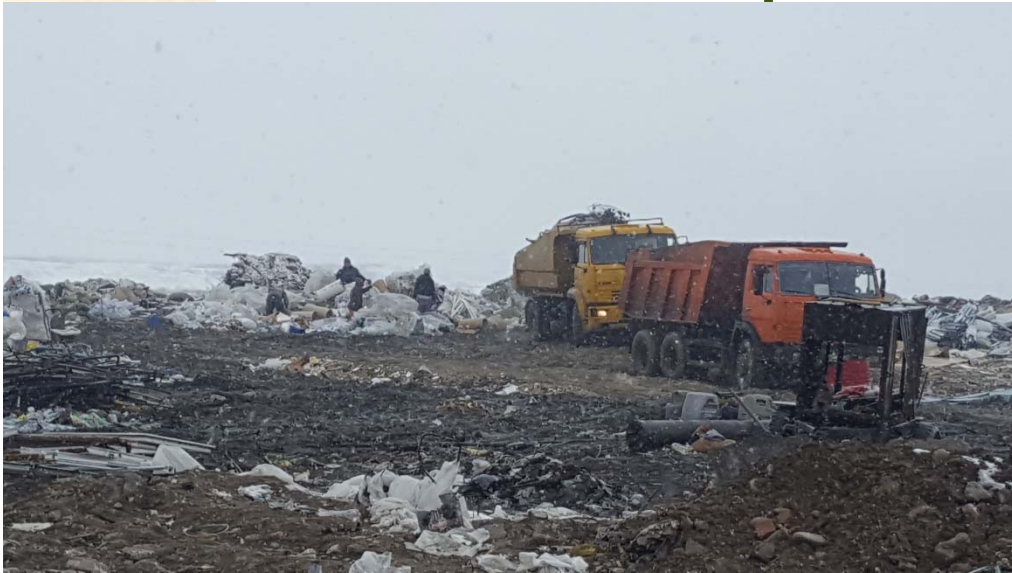
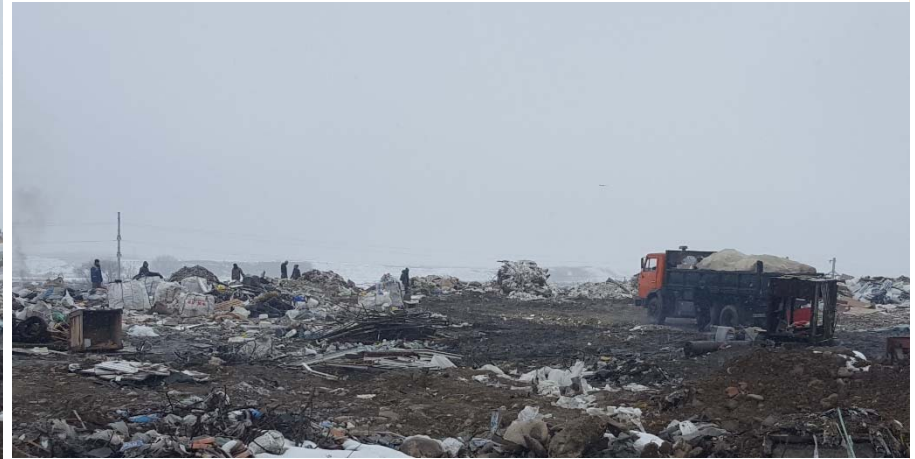
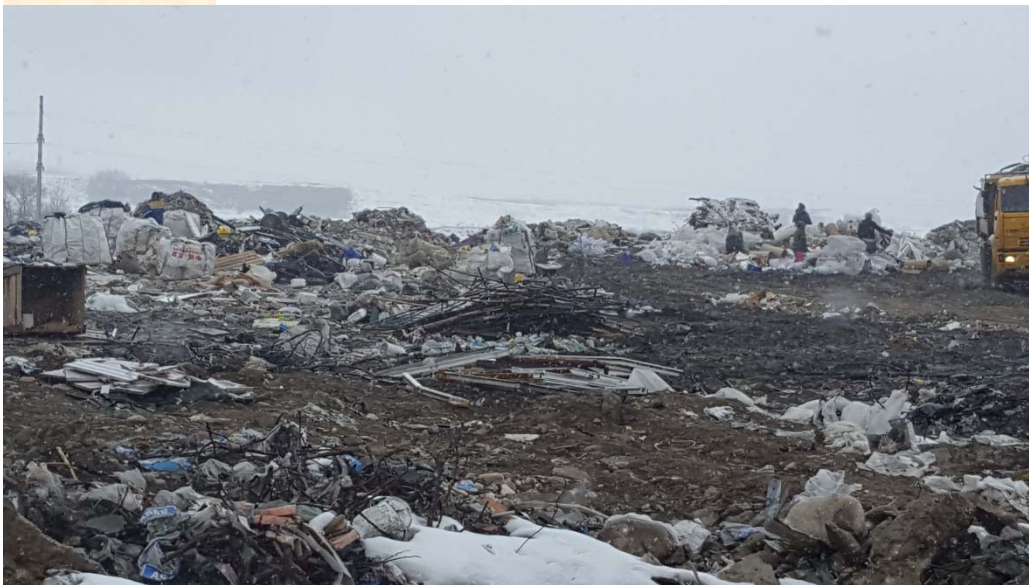
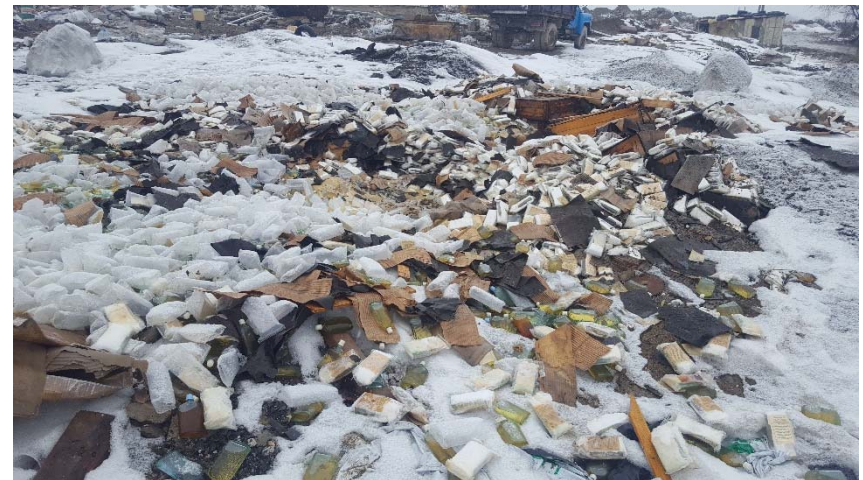
Pictures of the current state with visual observation dump near the village of Koksay

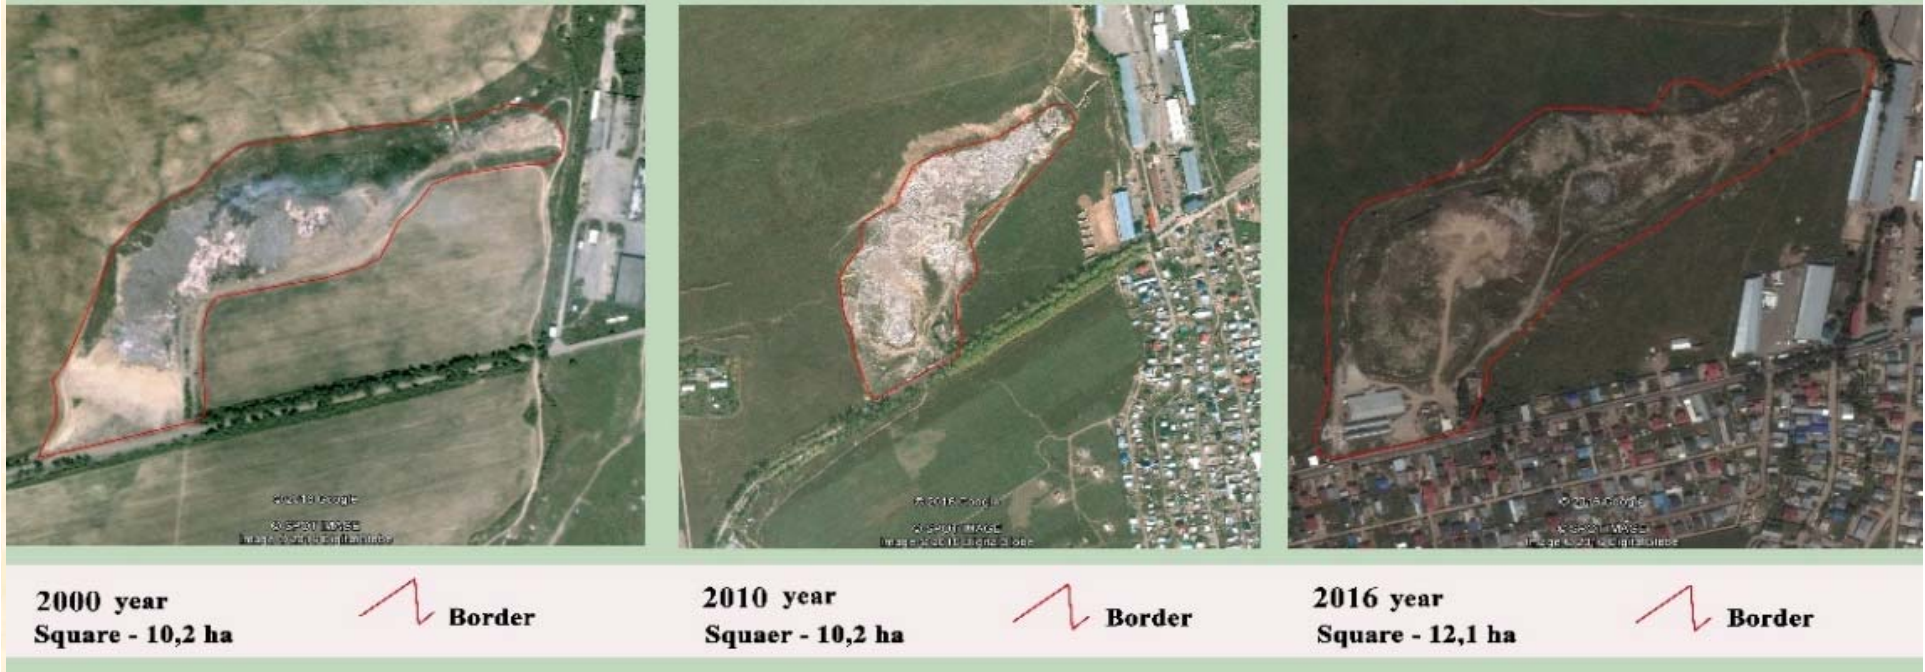
Figure 8 - Dynamics of changes in the boundaries of the solid waste dump near the village of Algabas for 2000-2016. [28]

Dump Algabas is located in Algabas microdistrict of Almaty. The figure shows that in 2000 the area was 10.2 hectares, and in 2016, it was 12.1 hectares. The change in borders has not increased significantly. The dump waste is evenly distributed. The shape of the dump boundary is clearly distinguished. Kargalinka River flows near the dump to the east. The spontaneous dump is officially closed in 2012, it refers to the recultivated, and it does not have a complete fence along the actual border, as well as there is no sanitary protection zone along the perimeter of the dump (Figure 8).

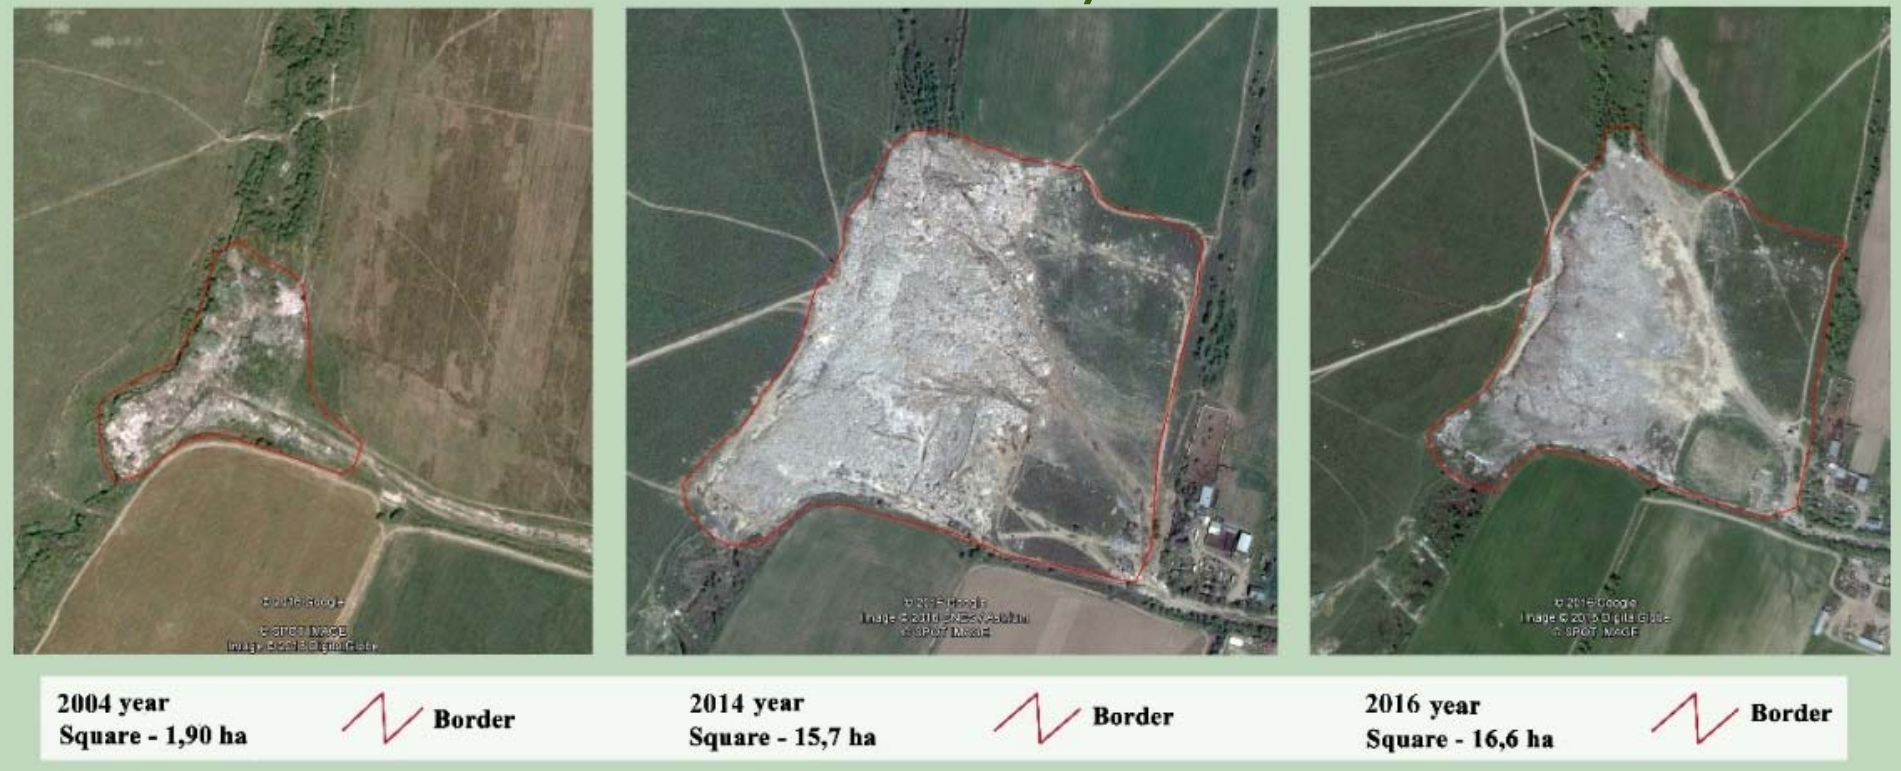
Figure 10 - Dynamics of changes in the boundaries of the dump of MSW near the settlement "Pervomayka" for 2004-2016.

The dump near the settlement of Pervomayka is located near the settlement Pervomayka of the Ili district of Almaty region on the border of Almaty city. The nearest settlements are Pervomayka and Koyankus. The dump has been in operation since 2004, it refers to recultivated, it does not have a complete fence along the actual border. There is an increase in the territories from the initial state. In 2004, the dump area was 1.90 ha. In 2016, it increased by 14.7 hectares and was 16.6 hectares. On space images, it is possible to observe a smooth compaction of waste along the perimeter of the dump (Figure 10).

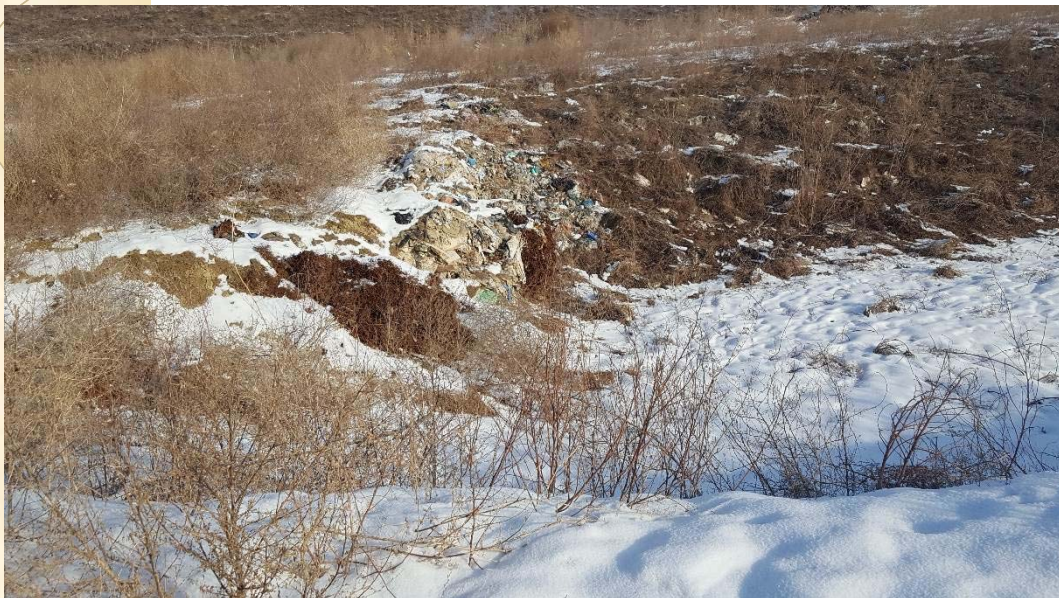
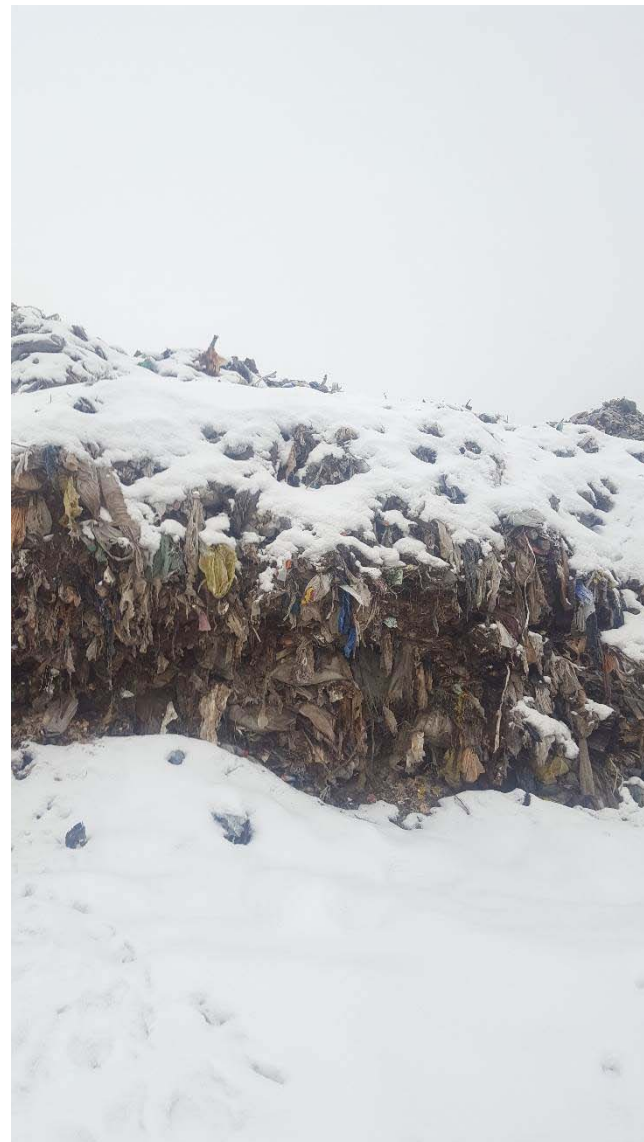
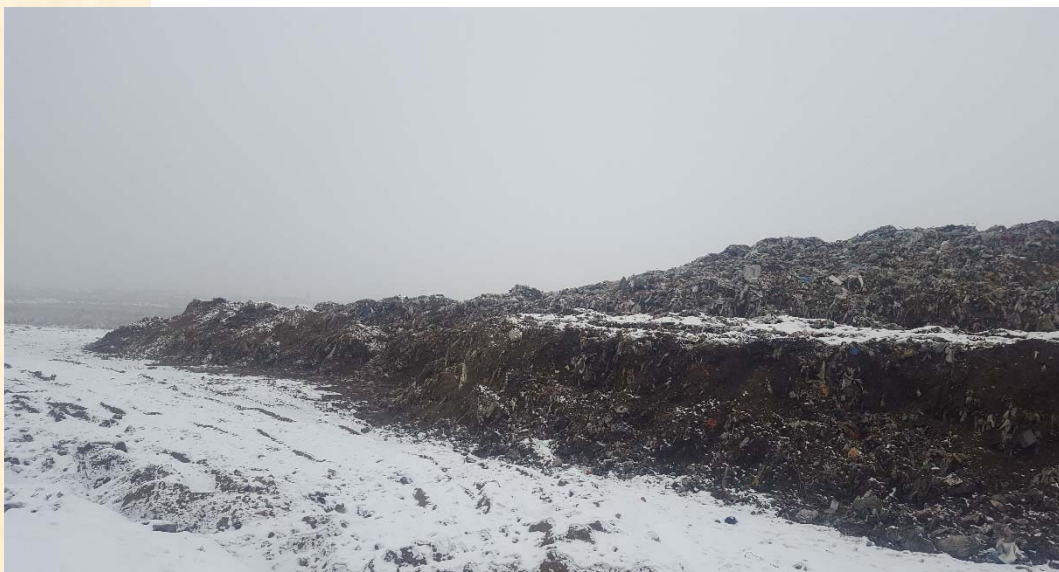
Pictures of the current state with visual observation settlement "Pervomayka"
