# BIOLOGICAL REMOVAL OF HYDROGEN SULPHIDE FROM LANDFILL SITE BIOGAS

Rania Ibrahim<sup>1</sup>, Shahram Navaee-Ardeh<sup>1</sup>, Hubert  
Cabana<sup>1</sup>

<sup>1</sup>Department of Civil Engineering, University of Sherbrooke  
l'Université, Sherbrooke, Québec, J1K 2R1, Canada

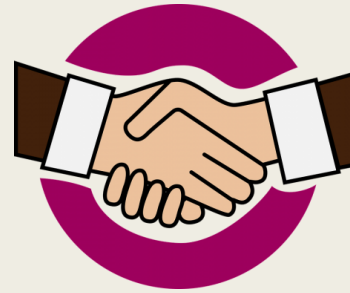
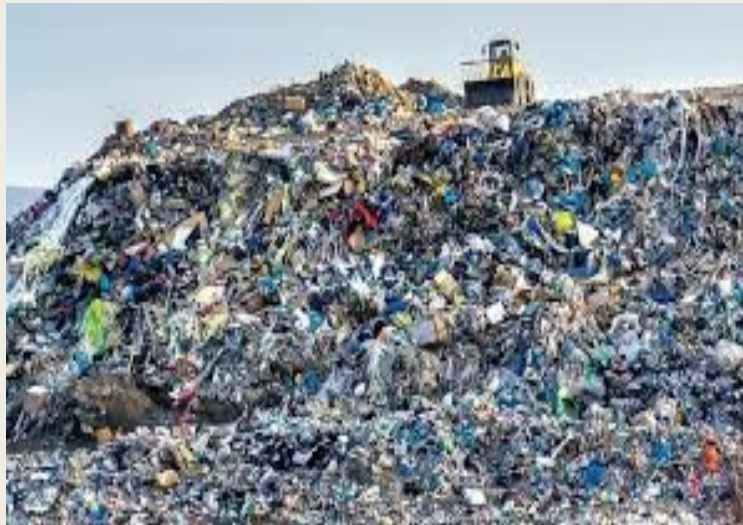
Background and problem justification

Anaerobic digestion

Biogas:  
 $\text{CH}_4$   
 $\text{CO}_2$   
 ~~$\text{H}_2\text{S}$~~

hydrogeneration

Bio-methanol

Reforming

Bio-hydrogen

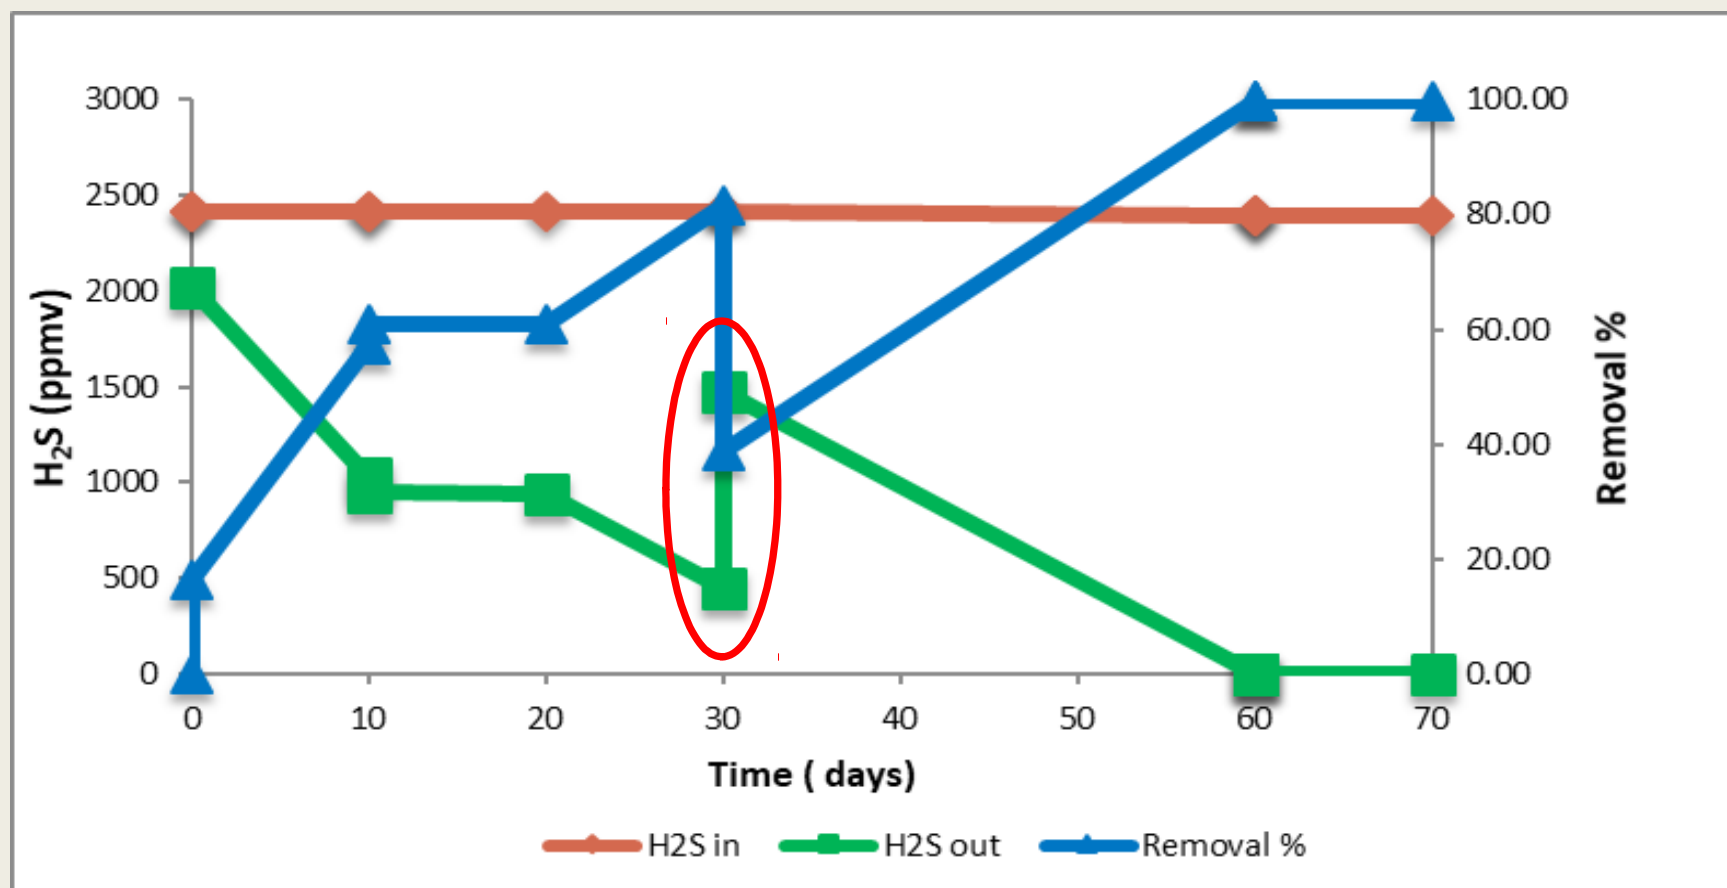
Biodegradation test of  $H_2S$  in the laboratory
